**KARAKTERISTIKE TERMOZAŠTITNIH PREVLAKA VSDP-11****CHARACTERISTIC  
THERMOPROTECTIVE COATING VSDP-11****Božidarka Arsenović, Zorana Živić, Slavko Vulić, Boško Ivanović***„Orao“ a.d., Bijeljina, Republika. Srpska***Izvod**

*The test samples for quality examinations of the thermoprotective coating VSDP-11 was cut from blades of the first and second stage of turbine rotor engine VIPER 632/633. Accumulation of thermoprotective coating on the blades was done by method of the target disprsn with using arc evaporator. This paper describe the results of examination microhardness HV 0.2, athesion of coating to basic material, metalografic micrographs as aim for giving the answer on question of connection between basic material and coating, as the porosity and thickness of coating too, with takig of photographs of microsucfures on three transversal cuttings of blades. It is confirmed the reachig of satisfied mechanical and structural-morphological characteristic, as on coatig of the first stage blade the same as on coatig of thefirst stage blade the same as on coating of the second stage blade of engine turbine rotor.*

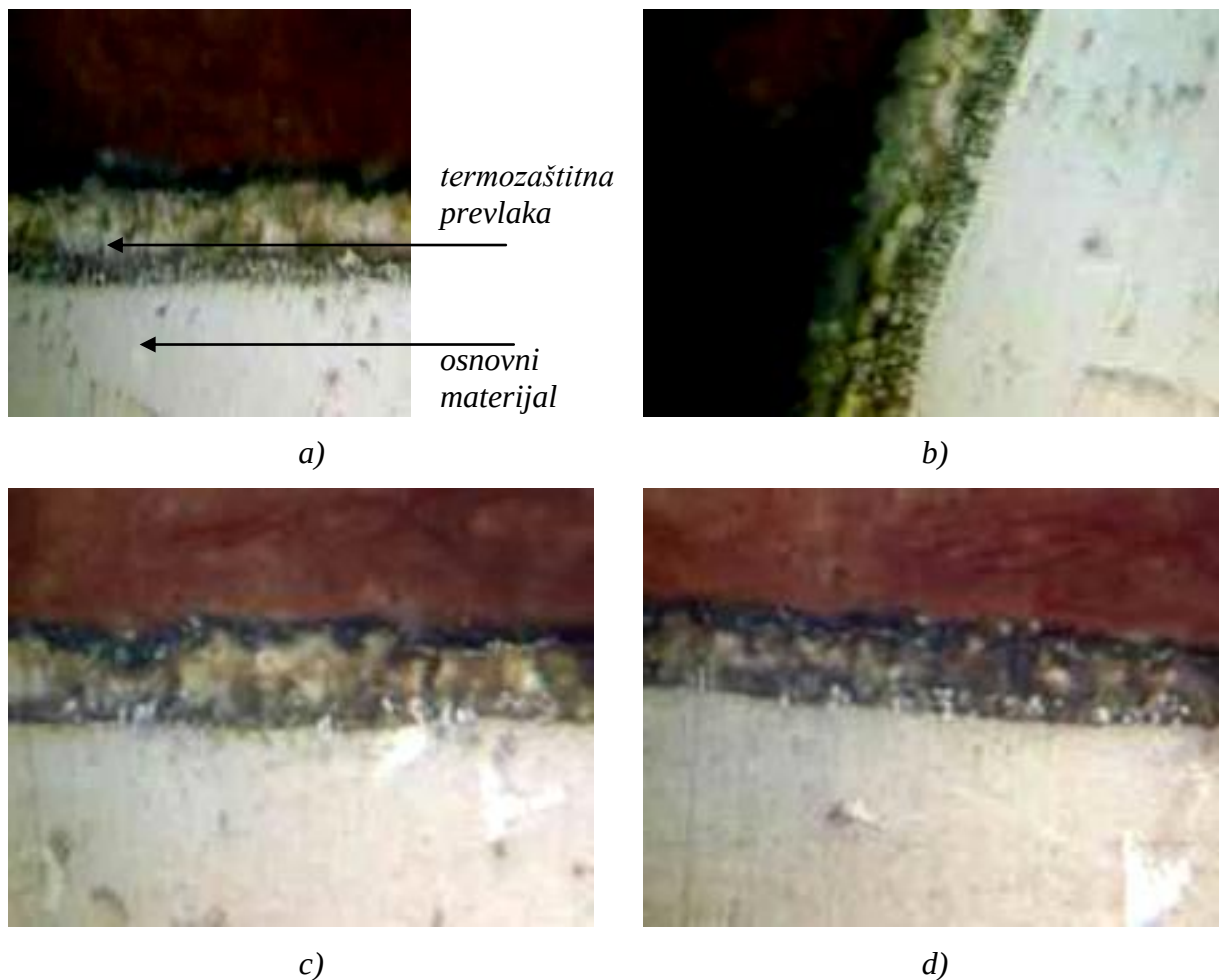
Slika 3. Mikrofotografije izgleda spoja osnovnog materijala i prevlake VSDP-11<sup>1)</sup> na posmatranim presecima lopatice 1. stepena rotora turbine

a) P-1 (napadna ivica), uvećanje 400 puta

b) P-1 (prikazano merno mesto 2 merenja debljine prevlake sa slike 4), uvećanje 400 puta

c) P-2 (napadna ivica), uvećanje 400 puta

d) P-3 (napadna ivica), uvećanje 400 puta

Na posmatranim presecima lopatice 1. stepena rotora turbine zapažena je dobra veza između osnovnog materijala i nanešene prevlake, posmatranjem uzorka pri uvećanju od 200 puta nije uočeno prisustvo pora. Prisustvo oksida i nevezanih čestica je neznatno i nalazi se u okviru kriterijuma prihvatljivosti.

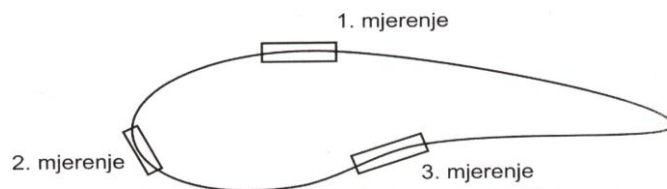
*Slika 4. Šematski prikaz mesta merenja debljine prevlake*

Prema rezultatima izmerenih debljina prevlake može se zaključiti da se debljine prevlake za lopatice 1. stepena kreću u intervalu od 34 do 44  $\mu\text{m}$  a za lopatice 2. stepena od 34 do 42  $\mu\text{m}$  i nalaze se u okviru prihvatljivih vrednosti [3].

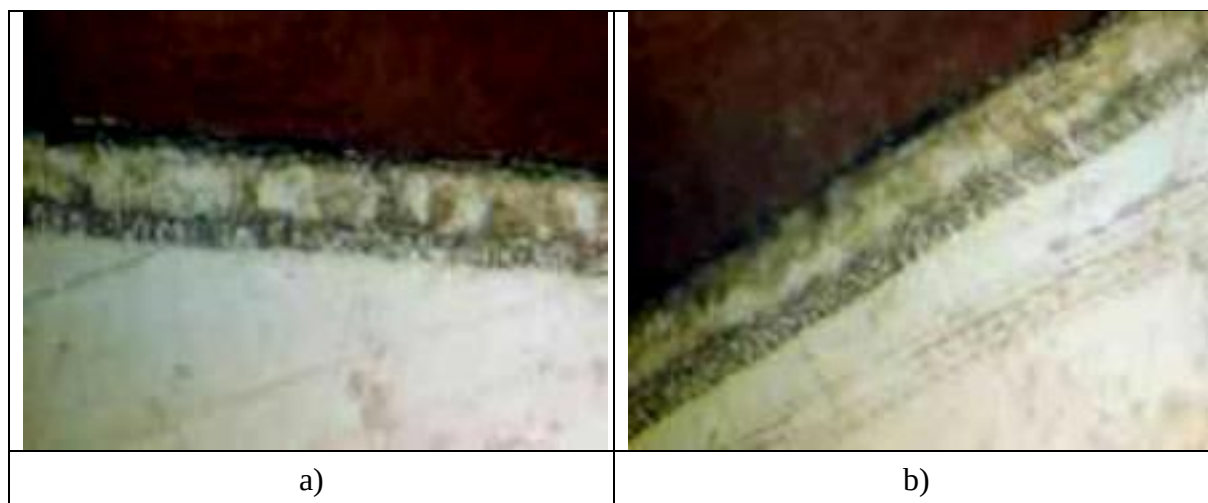
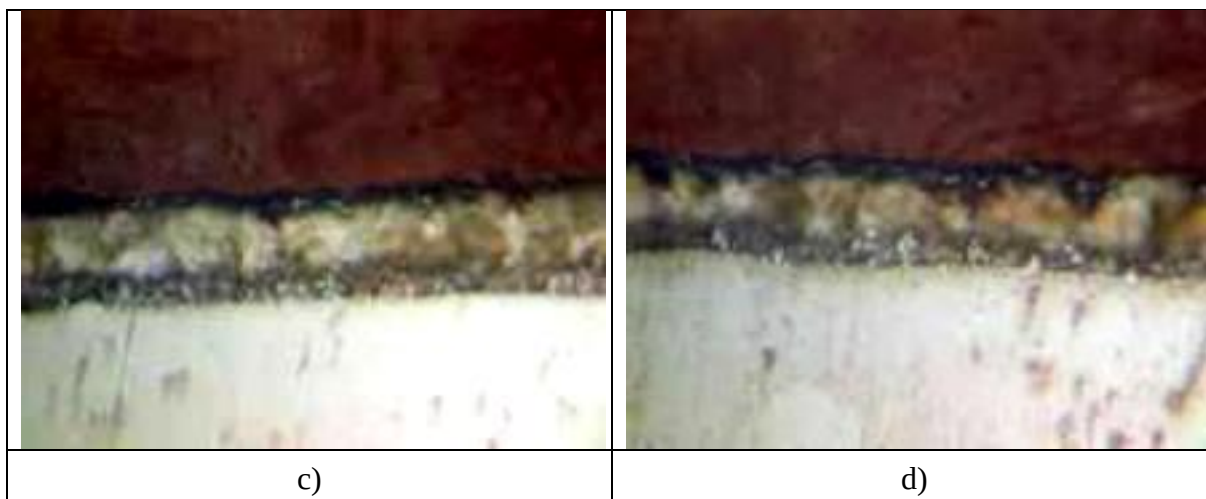
*Slika 5. Mikrofotografije izgleda spoja osnovnog materijala i prevlake VSDP-11 na posmatranim presecima lopatice 2. stepena rotora turbine*

- a) P-1 (napadna ivica), uvećanje 400 puta*
- b) P-1 (prikazano merno mesto 2 merenja debljine prevlake sa slike 4), uvećanje 400 puta*
- c) P-2 (napadna ivica), uvećanje 400 puta*
- d) P-3 (napadna ivica), uvećanje 400 puta*

Iz prikazanih mikrofotografija očigledno je da je postignuta dobra veza osnovnog materijala i nanešene prevlake i kod lopatica 2. stepena rotora turbine, pri posmatranju uzoraka u nenagriženom stanju potvrđena je dobra poroznost prevlake. Prisustvo oksida i nevezanih čestica je neznatno i kreće se u okviru dozvoljenih granica [3].

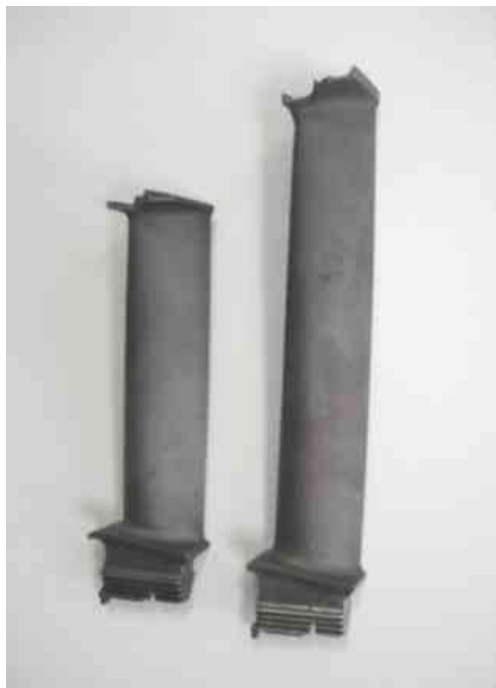
*Slika 6. Izgled lopatica 1.i 2. stepena rotora turbine nakon izdržanih 450 ciklusa termocikličnog zamora*

Termociklično zagrevanje na temperaturi od 900 do 950<sup>0</sup>C a zatim hlađenje do 250<sup>0</sup>C na vazduhu izdržale su lopatice kako 1. stepena tako i lopatice 2. stepena rotora turbine. Nije došlo do oštećenja napadnih strana lopatica i kod izdržanih 50 ciklusa zagrevanja od 900 do 950<sup>0</sup>C a zatim hlađenjem u vodi.
